**TRANSPORTATION SCIENCES CENTER
ACCIDENT RESEARCH GROUP**

CALSPAN ON-SITE SCHOOL BUS/PEDESTRIAN ACCIDENT INVESTIGATION

CALSPAN CASE NO. 95-6

SCHOOL BUS: 1989 BLUE BIRD TYPE D BODY

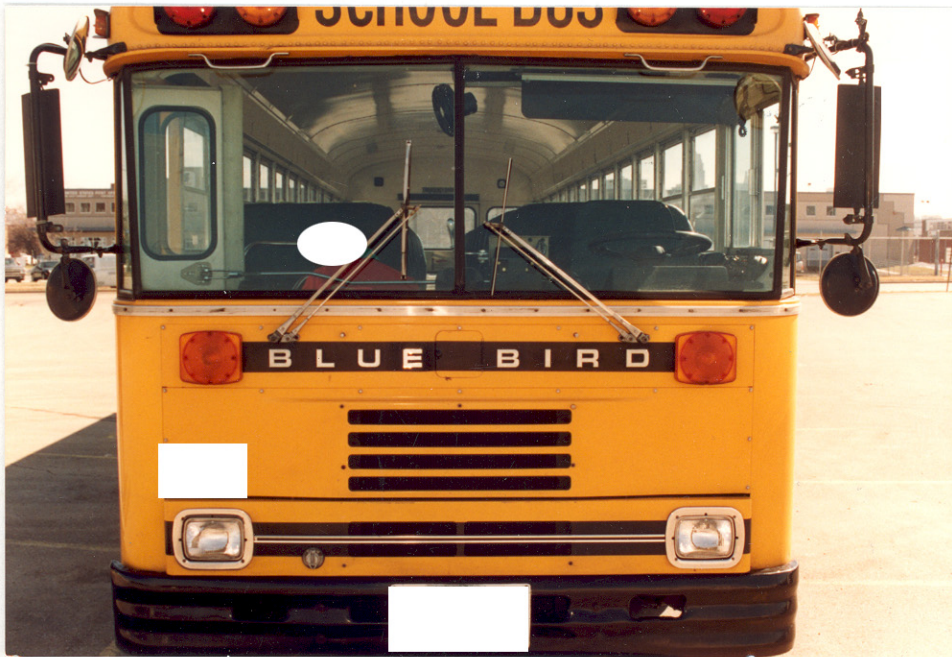
1. View of the frontal plane of the Type D (Forward Control) School Bus manufactured by Blue Bird.

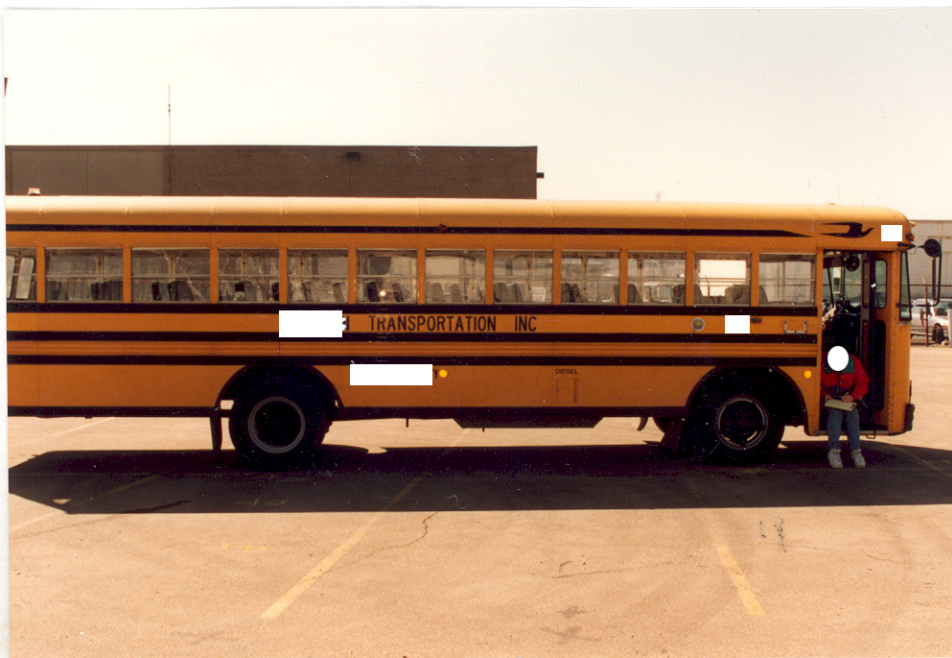
2. Overall view of the right side plane of the School Bus.

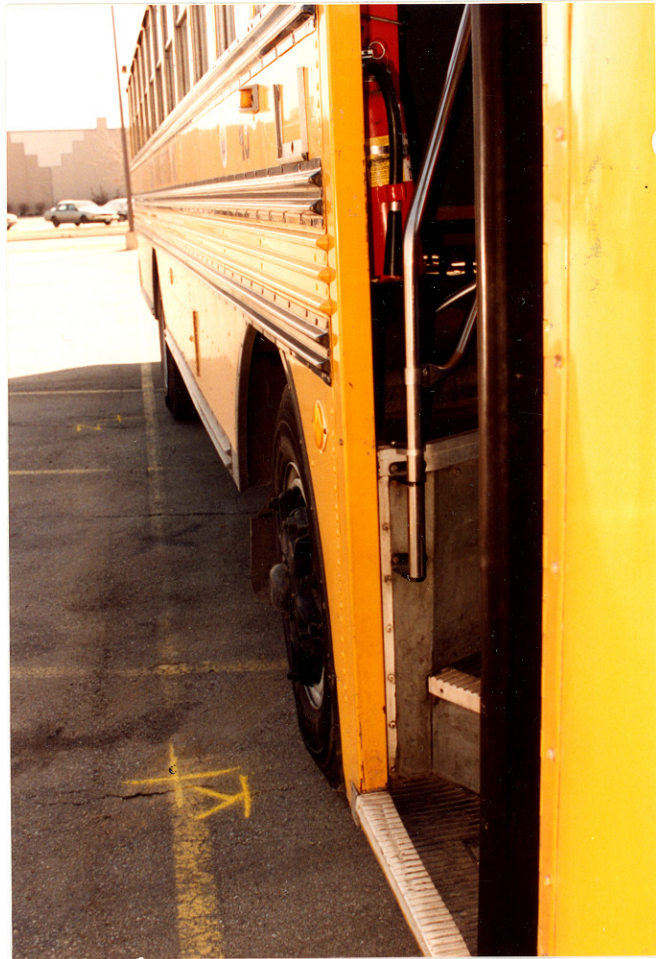
3. Longitudinal view of the right side looking rearward from the leading edge of the egress door.

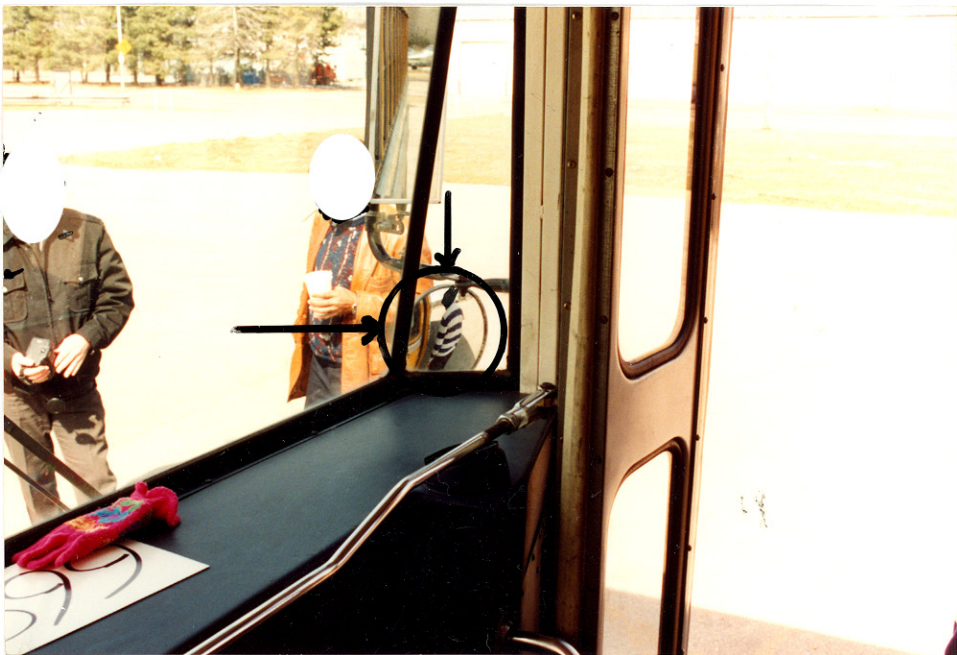
4. Photograph depicts the conspicuity of the pedestrian in the lower convex mirror.

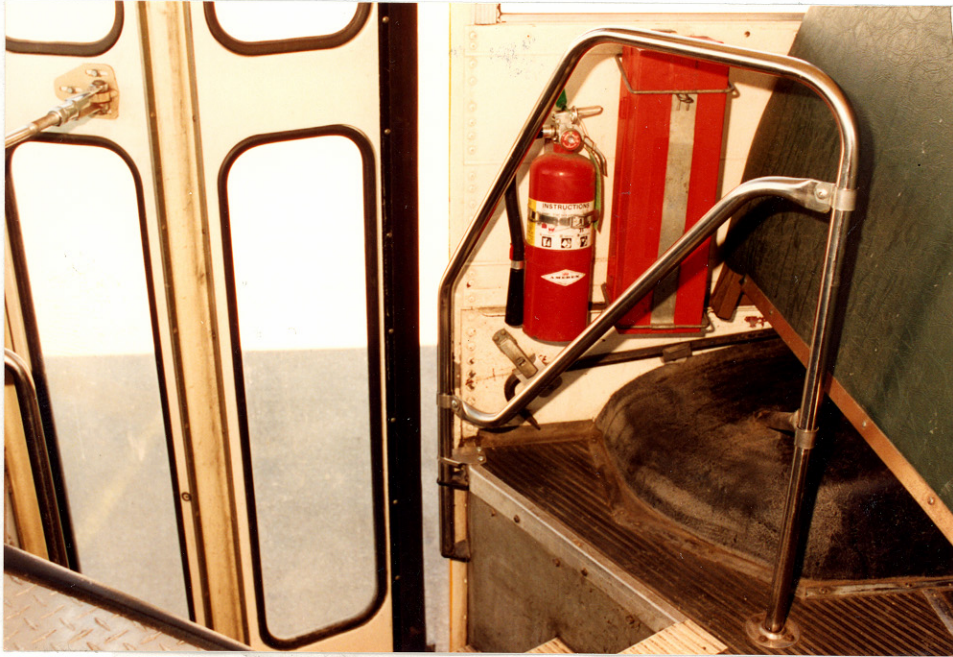
The accident involved three major contributing factors. The first was the handrail which provided a slot between the flat end on the stainless steel rail and the clamp which attached the rail to the vertical support. This slot created a mechanism for the drawstring to become snagged in the hand rail. Secondly, the driver did not provide the pedestrian with sufficient time to clear the bus before closing the door and accelerating from the curb. In addition, she failed to visually track the students as they exited the bus to ensure that they had cleared the vehicle prior to departing from the bus stop. Furthermore, the bus driver failed to check the vehicle's mirrors for pedestrian's prior to accelerating from the bus stop. She did check the right side convex mirror approximately six seconds into the acceleration mode, however, at this point in time, the accident had already occurred.

5. View of the handrail system along the right side (rearward side) of the stair well.

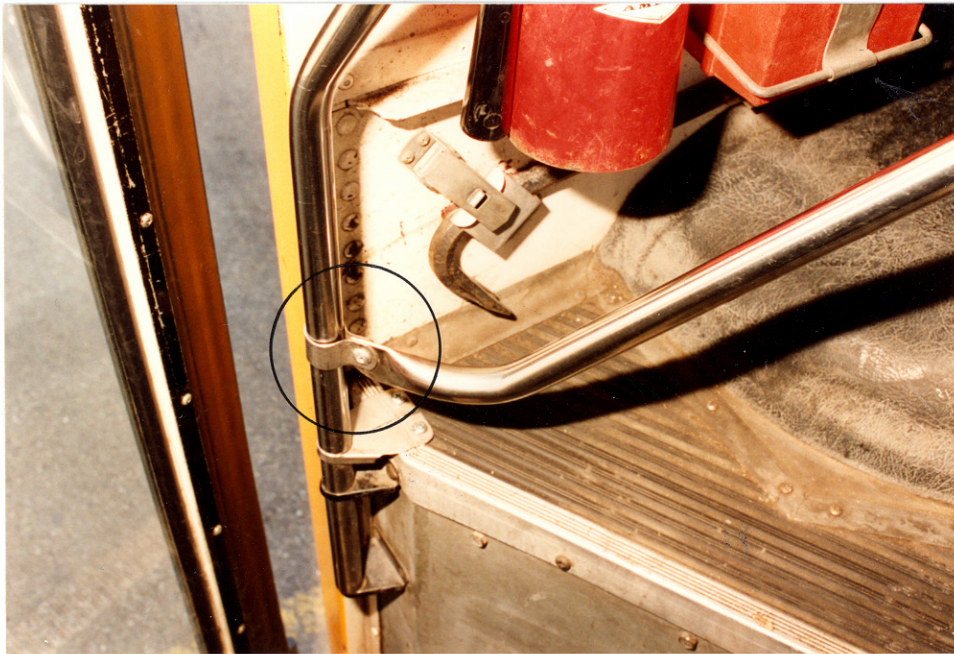
The post-accident modification of the handrail is not a successful remedy to the potential snagging of a drawstring or similar object. During the course of our on-site investigation, we passed a jacket drawstring along the modified hand rail of the involved Blue Bird school bus and the leather tab at the end of the drawstring became snagged at the junction of the handrail and its attachment point with the vertical support. (Refer to preliminary photograph nos. 10-13.) The radius that was ground to the upper and lower surface of the flat end of the rail did not eliminate the void that snagged the drawstring.

6. Closer view of the post event modification to the lower aspect of the replacement handrail showing the attachment bracket with the upper handrail adjacent to the egress door opening.

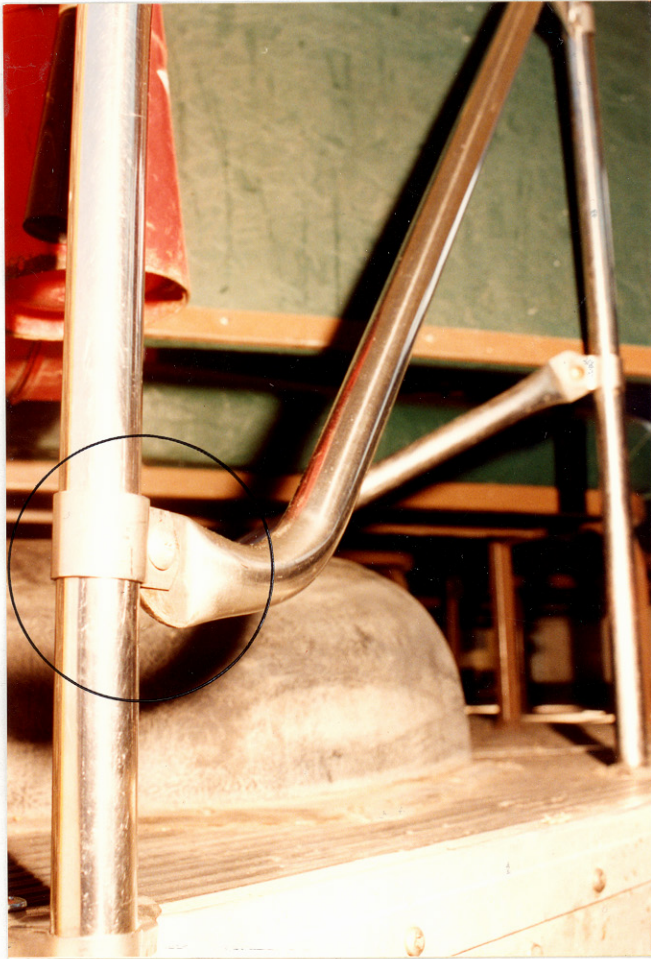
7. View of the post event modification of the lower aspect of the replacement rail at the junction of the attachment bracket looking inward from outside of the School Bus.

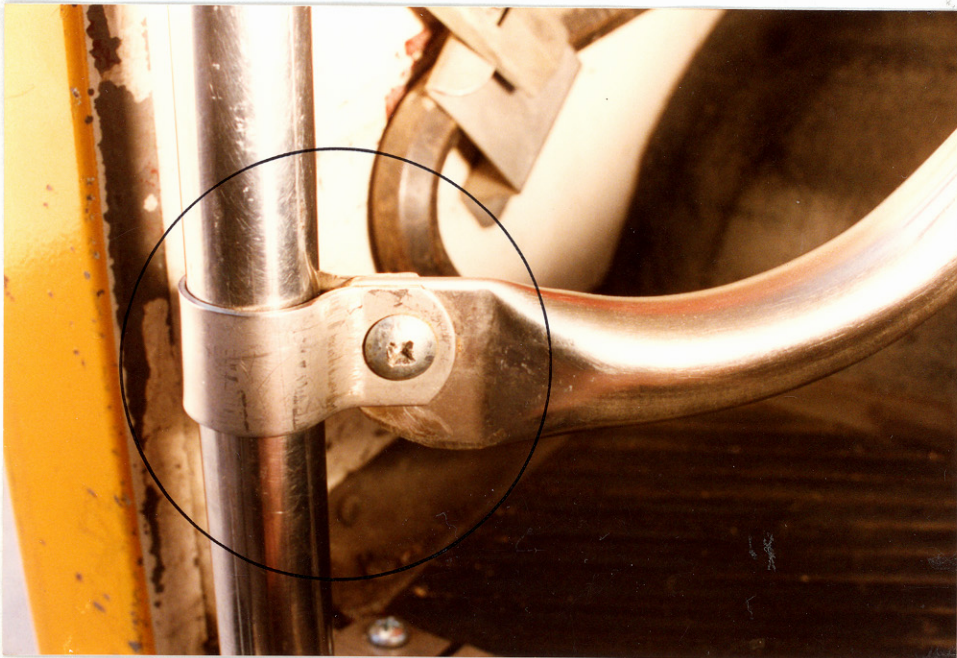
8. Close-up view of the lower rail attachment showing a rounded lower edge which was modified from a square edge after this event.

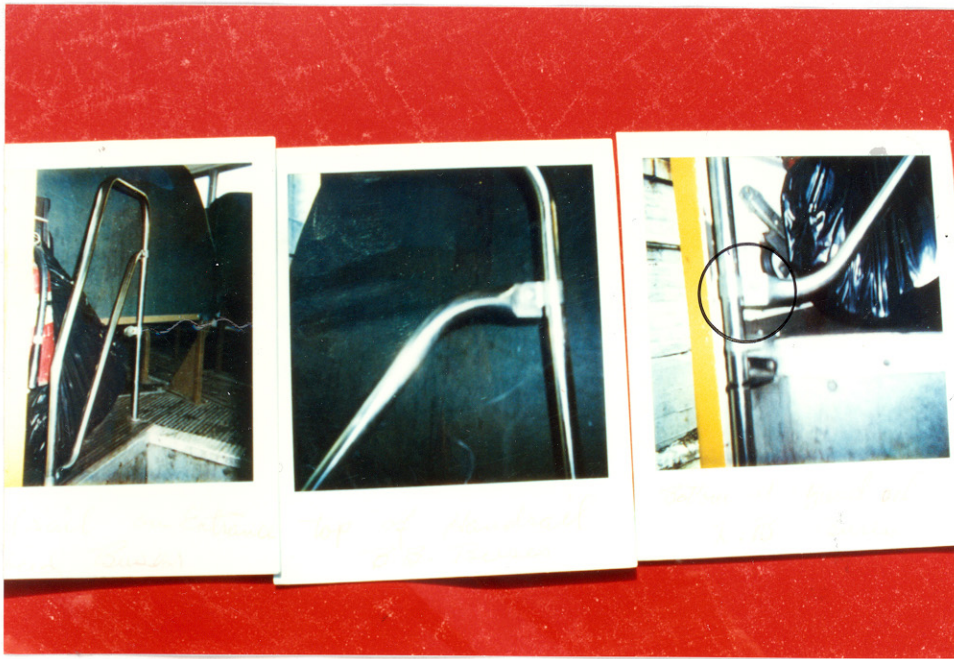
The *Audiocam* system did not record the pedestrian's actions as she descended the steps and exited the school bus. The metallic tab on the right side of her jacket's drawstring became snagged in the slot that was formed between the replacement handrail and the stainless steel clamp that attached the diagonally orientated handrail to the vertical support. This probably occurred as the pedestrian stepped onto the bottom step, or as she was exiting the vehicle. As noted from the videotape, the pedestrian was provided with a scant time interval (approximately 2 seconds) to descend the steps and exit the bus prior to the driver closing the door and accelerating from the curb.

9. Views of the lower replacement handrail prior to post event modification.

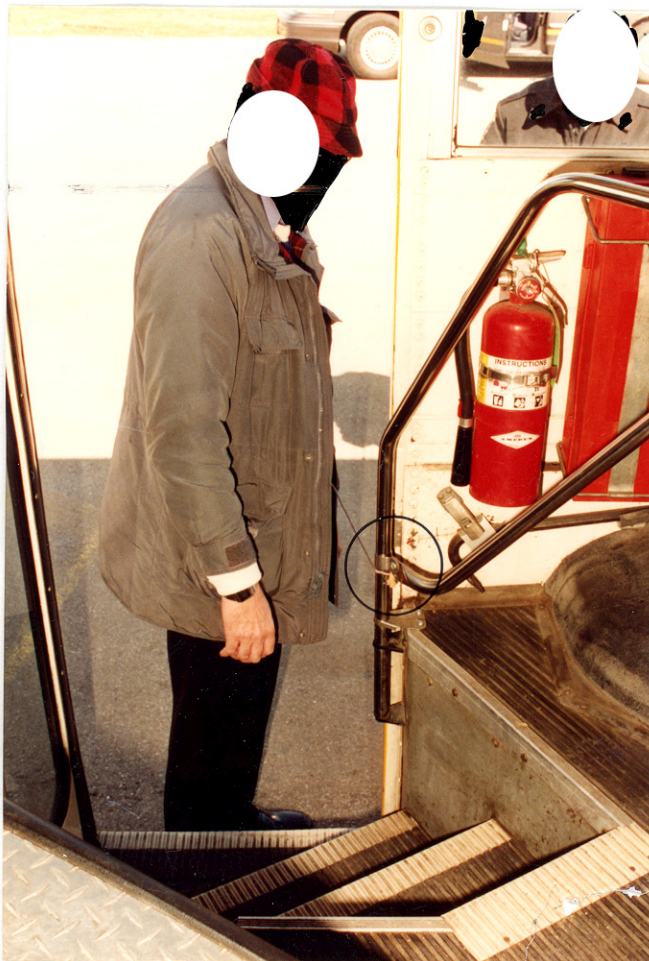
10. Simulation of the drawstring snag in the junction of the lower replacement handrail and attachment bracket.

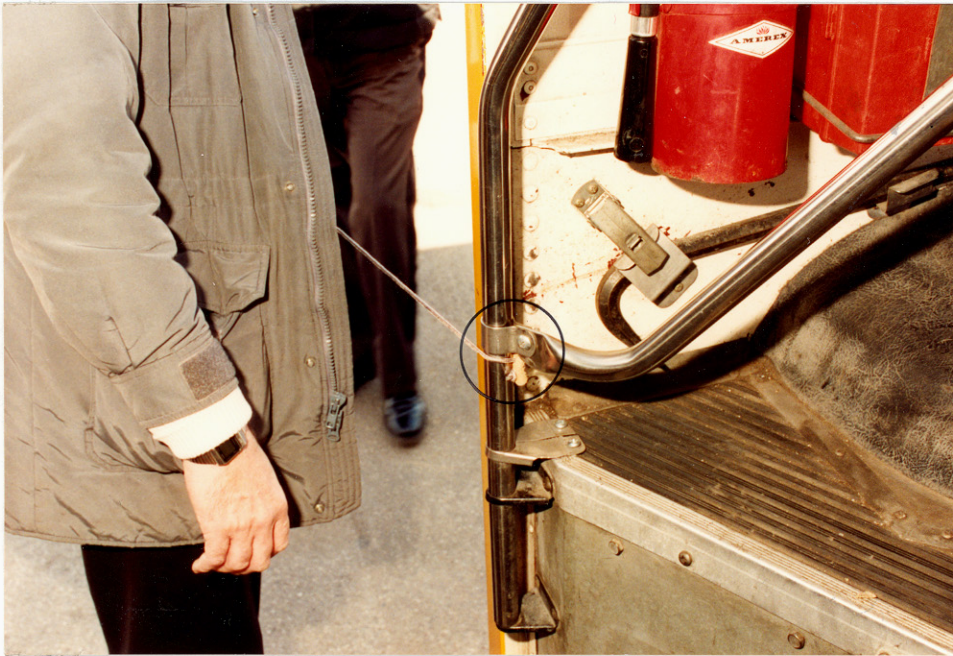
11. Closer view of the simulated drawstring snag in the junction of the lower replacement handrail and attachment bracket.

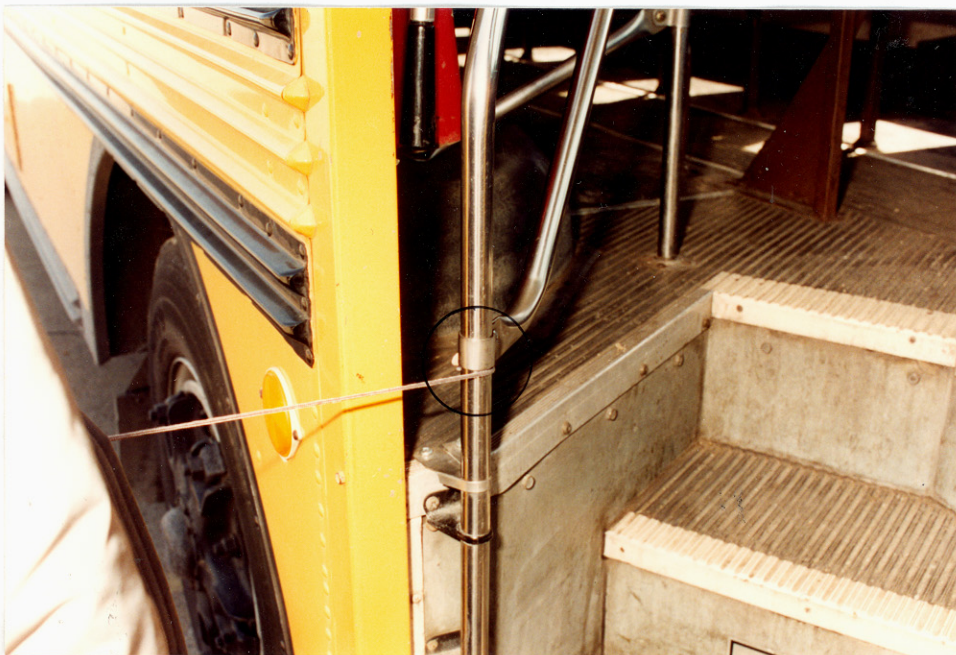
12. View of the simulated drawstring snag from outside of the School Bus.

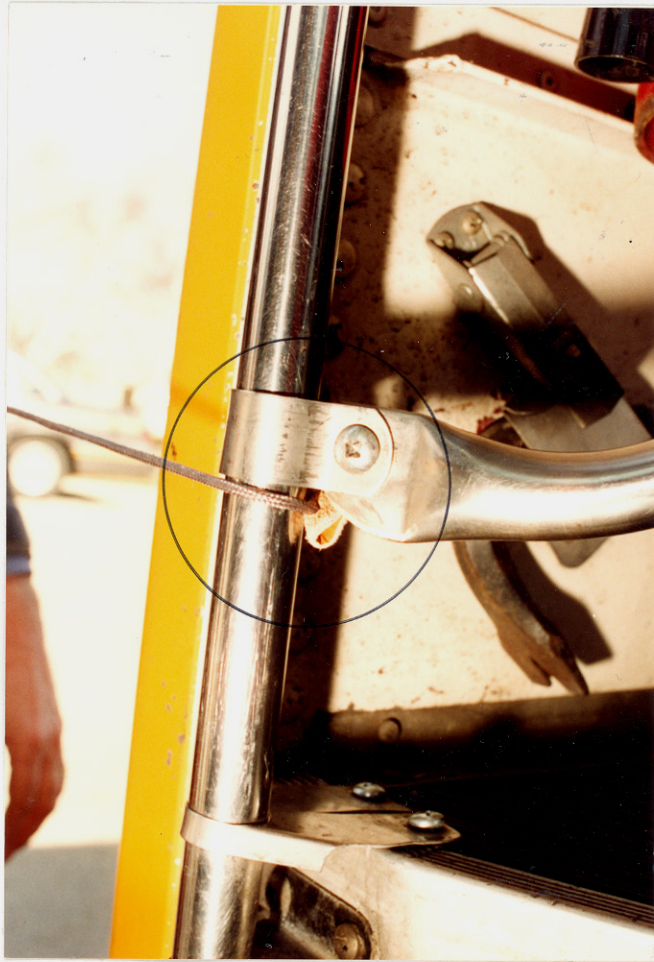
13. Close-up view of the simulated drawstring snag highlighting the leather slack adjuster as the snagging agent.

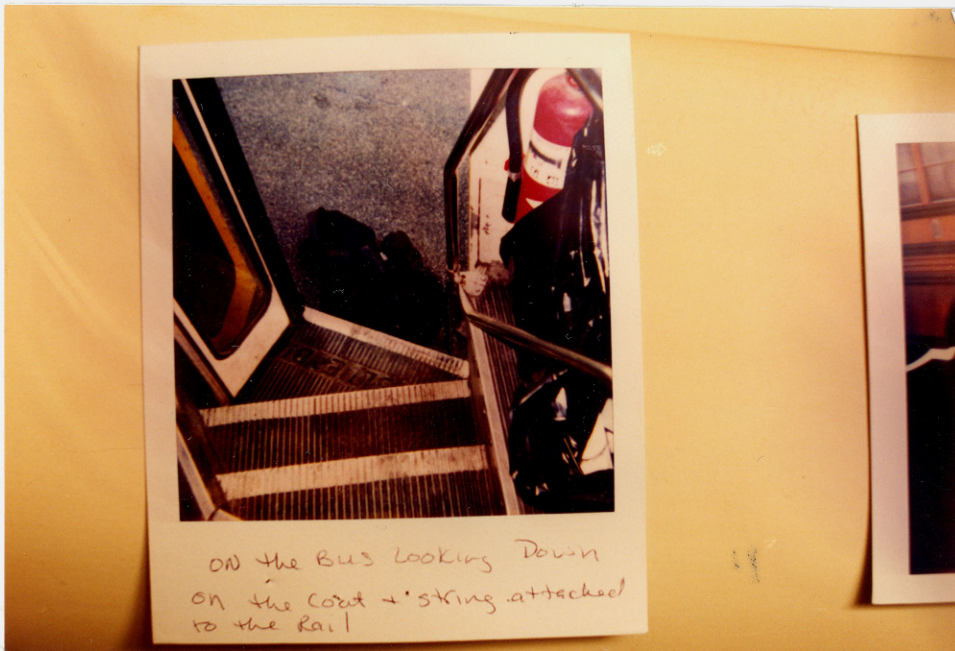
The pedestrian's jacket drawstring remained attached to the handrail of the school bus as the vehicle came to rest. The investigating police officer observed the draw string in the handrail and photographed the engagement at the scene. There was no damage to the drawstring or to the pedestrian's leather jacket.

14. On-scene photograph of the drawstring caught in the junction of the lower replacement handrail and attachment bracket. The pedestrian's coat is located on the ground at the base of the stairs.

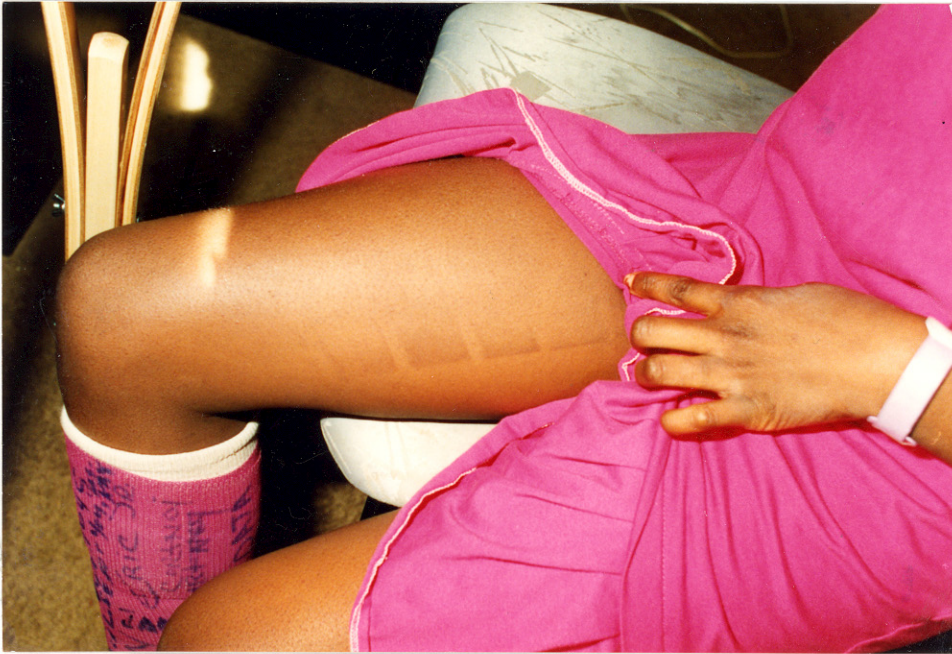
The pedestrian's jacket was subsequently pulled by the accelerating school bus as the drawstring remained snagged in the handrail. The initial acceleration probably rotated the pedestrian in a clockwise direction and into the right side surface of the bus. The pedestrian dropped her book bag as her jacket was pulled off her body. Her mother stated that the jacket was found with the sleeves turned inside out, indicating that the jacket had been forcibly pulled off her body. She probably began to fall to the asphalt road surface and was contacted by the sidewall and edge of the tire tread of the right rear tire. This contact produced a patterned tire tread transfer that was longitudinally orientated on the medial aspect of the right thigh. The contact probably rotated the leg in a clockwise direction with loaded the pedestrian's right ankle resulting in a chip fracture of the ankle. Based on the injury to the ankle, it was possible that the ankle was bearing some of the pedestrian's weight, indicating that she was in an upright, or partially upright orientation when contacted by the tire.

15. View of the pedestrian's right leg showing a tire imprint mark.

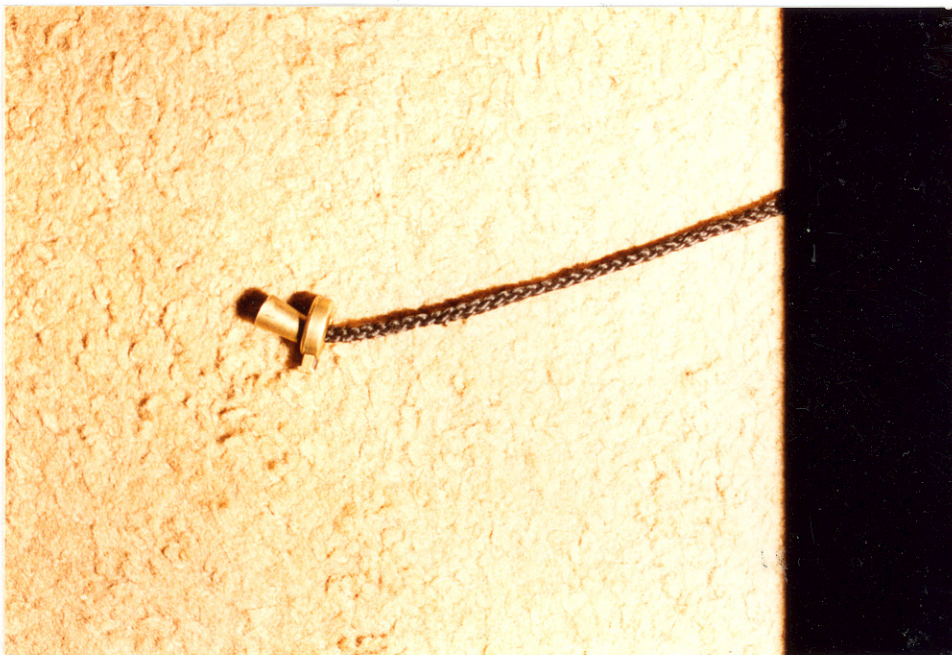
16. View of the pedestrian's drawstring slack adjuster which was caught in the junction of the lower replacement handrail and attachment bracket.
